# FUNDAMENTALS SURVEY

08/01/2025

## Example Fundamentals Survey

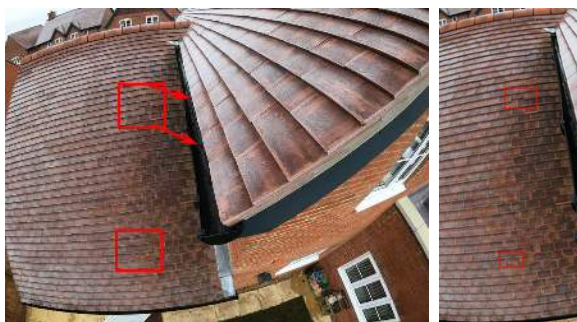
2

Underlay below the roof covering is not dressed into the gutter to allow for any rainwater that manages to pass the covering to escape into the rainwater services at the eaves level as per NHBC 7.2.14., Tiles do not appear to be in horizontal alignment. This is an aesthetic concern only, and likely due to the battens not being installed straight on the roof beneath the tiles.
