NEW BUILD SNAGGING SURVEY

29/01/2025

Example Snagging Survey

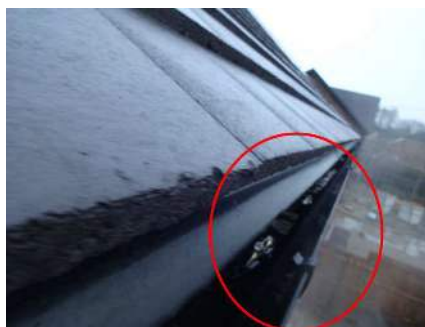
The canopy is damaged and should be replaced if it cannot be repaired

Building material waste in the gutter to remove to allow rainwater to flow adequately

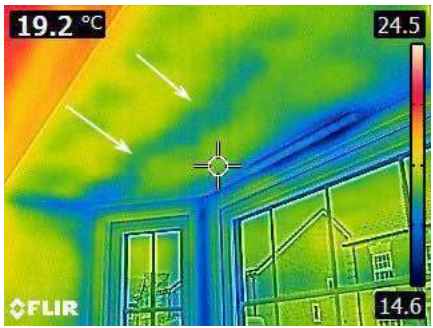
1

Thermal anomaly to the ceiling at the bay, likely caused by gaps in the insulation coverage or thermal bridging at the junction of the roof where poorly separated.

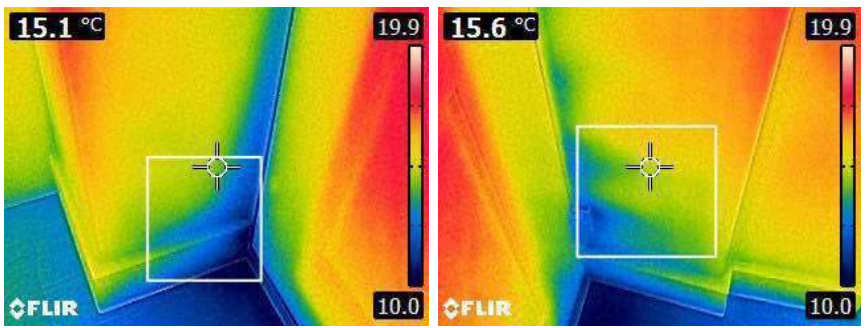
2

There appears to be a draught coming from the door or incorrectly fitted cavity closer

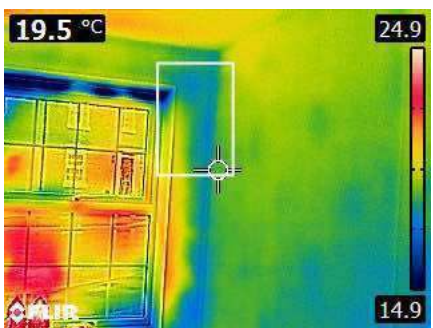
3

Thermal anomaly to the wall, which suggests a possible lack of cavity wall insulation.

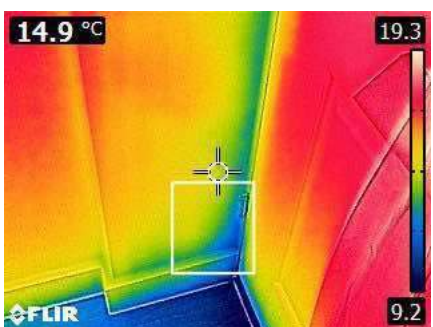
4

There appears to be a draught coming from the door

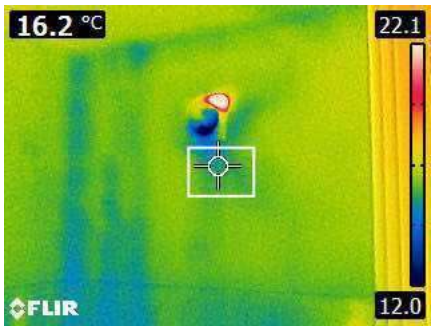
5

Thermal anomaly to the wall, which suggests a possible lack of cavity wall insulation.

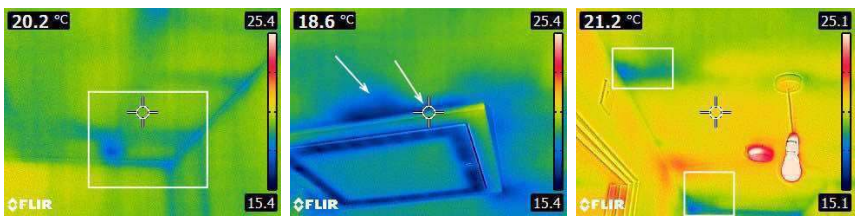
6

Thermal anomaly to the ceiling, which is caused by gaps in the loft insulation which will need to be fitted correctly.

Draughts around loft hatch, advise it is caulked

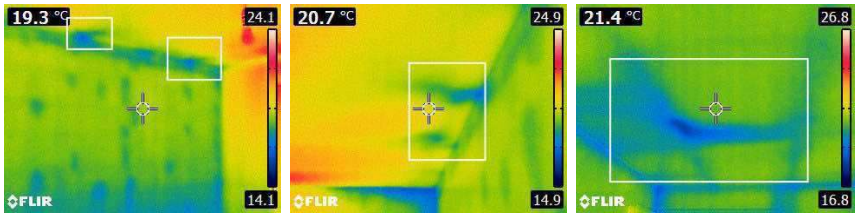
7

Thermal anomaly to the ceiling, which is caused by gaps in the loft insulation which will need to be fitted correctly., Thermal anomaly to the eaves, which is likely caused by missing or improperly laid insulation.

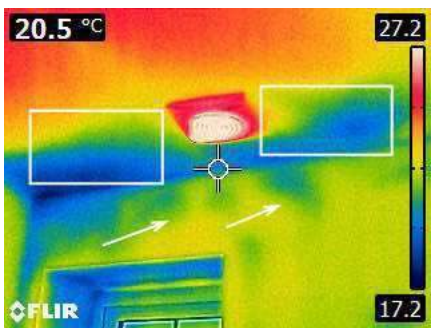
8

Thermal anomaly to the eaves, which is likely caused by missing or improperly laid insulation., Thermal anomaly to the plasterboard likely to be caused by air infiltration. This is usually caused by a lack of a continual ribbon of adhesive when dot and dab applied to the wall when installing the plasterboard sheets.

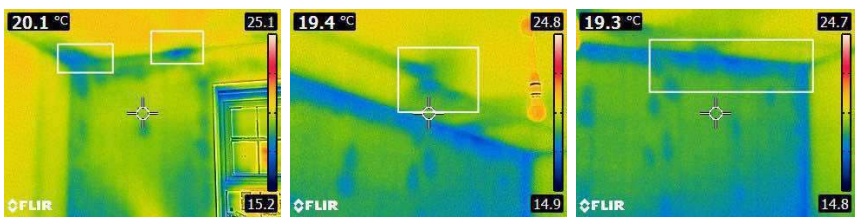
9

Thermal anomaly to the plasterboard likely to be caused by air infiltration. This is usually caused by a lack of a continual ribbon of adhesive when dot and dab applied to the wall when installing the plasterboard

sheets., Thermal anomaly to the ceiling, which is caused by gaps in the loft insulation which will need to be fitted correctly.

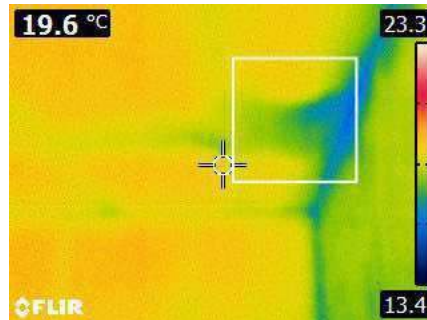
10 **Room:**
Bed 3

Thermal anomaly to the eaves, which is likely caused by missing or improperly laid insulation.

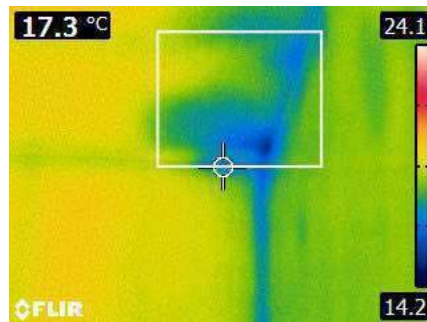
11 **Room:**
Bed 4

Thermal anomaly to the ceiling, which is caused by gaps in the loft insulation which will need to be fitted correctly.

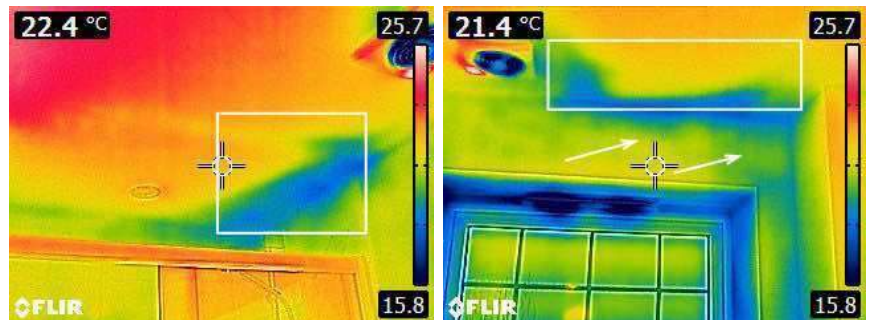
12 **Room:**
Bathroom 1

Thermal anomaly to the eaves, which is likely caused by missing or improperly laid insulation., Thermal anomaly to the plasterboard likely to be caused by air infiltration. This is usually caused by a lack of a continual ribbon of adhesive when dot and dab applied to the wall when installing the plasterboard sheets.

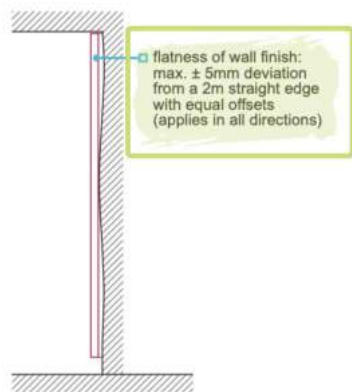
NHBC 9.1.3 Wall not flat

Wall is not flat and it is noticeable by eye. Walls should be flat within a $\pm 3\text{mm}$ deviation, measured using a 2m straight edge with equal offsets, as per NHBC 9.1.3

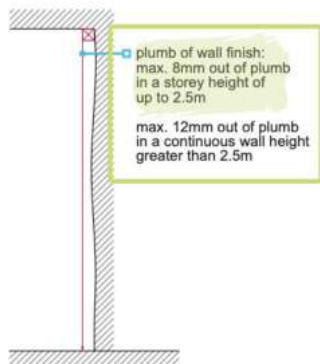
NHBC 9.1.3 Wall not plumb

10mm/1.2m
